December 14, 2016

## FRCSW Paints Its First MV-22 Osprey

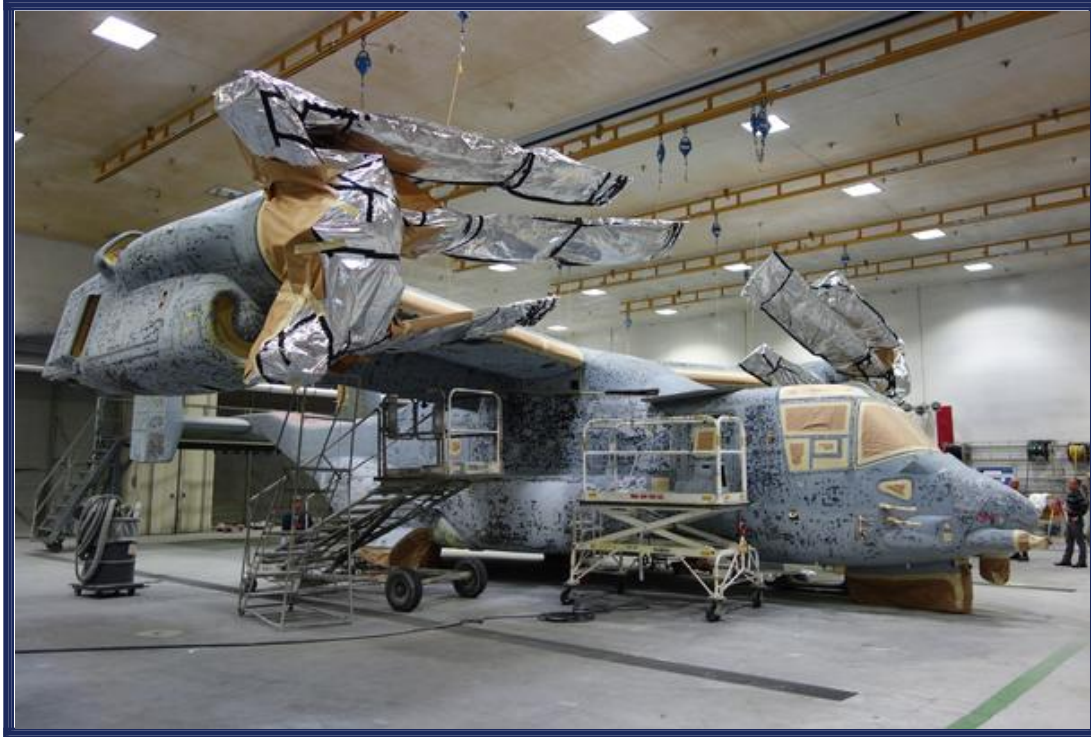
The MV-22 Osprey assigned to Marine Medium Tilt-rotor Squadron 161 (VMM-161) is pictured at the Fleet Readiness Center Southwest paint complex Nov. 19, 2016, during the aircraft's painting process. The aircraft requires hand/scuff sanding of its entire surface, which results in a "leopard" pattern appearance. U.S. Navy Photo

The MV-22 paint process requires hand/scuff sanding of the entire surface of the airframe; and with such a large aircraft, the paint complex team needed to ensure enough members were trained. The aircraft was swarmed, creating a “leopard” pattern look on the airframe without sanding into the Astro-Strike.
